DEPARTMENT OF TRANSPORTATION

Contract #: 04-0120F4Cty: SF/ALA Rte: 80 PM: 13.2/13.9File #: 69.28**WELDING INSPECTION REPORT****Resident Engineer:**Siegenthaler, Peter**Address:** 333 Burma Road**City:** Oakland, CA 94607**Report No:** WIR-018380**Date Inspected:** 26-Nov-2010**Project Name:** SAS Superstructure**OSM Arrival Time:** 700**Prime Contractor:** American Bridge/Fluor Enterprises, a JV**OSM Departure Time:** 1900**Contractor:** Zhenhua Port Machinery Company, Ltd (ZPMC), Changxing Island **Location:** Shanghai, China**CWI Name:** Zhu Feng**CWI Present:** Yes No**Inspected CWI report:** Yes No N/A**Rod Oven in Use:** Yes No N/A**Electrode to specification:** Yes No N/A**Weld Procedures Followed:** Yes No N/A**Qualified Welders:** Yes No N/A**Verified Joint Fit-up:** Yes No N/A**Approved Drawings:** Yes No N/A**Approved WPS:** Yes No N/A**Delayed / Cancelled:** Yes No N/A**Bridge No:** 34-0006**Component:** TOWER & OBG Components**Summary of Items Observed:**

TOWER JETTY

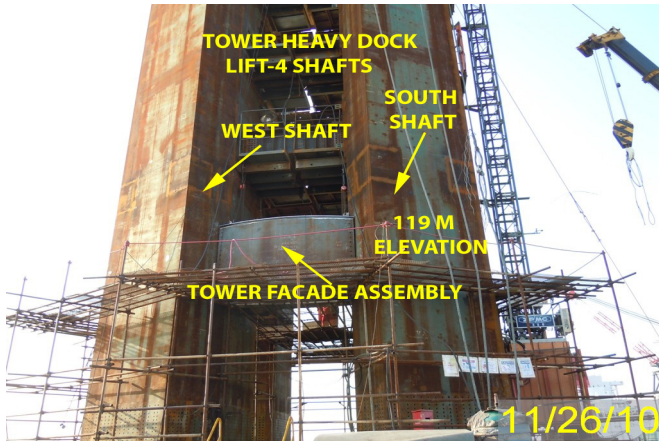
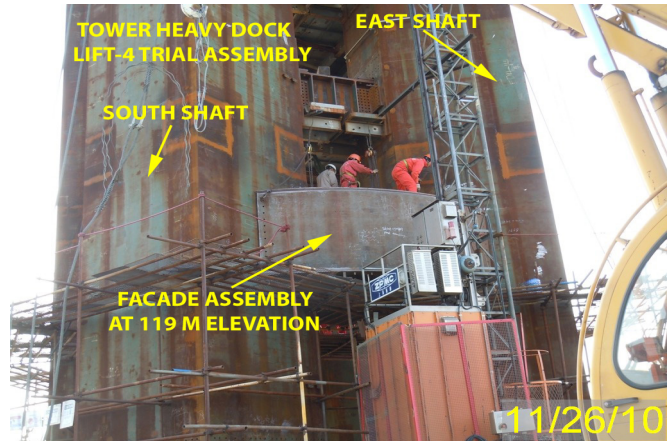
Visual Inspection Testing (VT) on lift-4 tower shafts for fit-lug plate cut-outs

This QA inspector performed VT on lift-4 tower shafts for fit-lug plate cut-outs at 119 M elevation on North, East, West and South shafts. It has been observed that ZPMC personnel have completed the repair work as per the TC-RFI-ZPM-0166R0 on North shaft. The member is identified as TOWER Component.
